Tamarack Lake is located 4 miles south of Duxbury, MN, in Pine County. It is a small lake covering approximately 71 acres with a shoreline length of 1.84 miles (Table 1). Tamarack Lake has no major inlets or outlets.

Water quality data have been collected on Tamarack Lake from 1982-2017 (Tables 2 & 3). These data show that the lake is oligotrophic/mesotrophic with fairly clear water conditions most of the summer and excellent recreational opportunities.

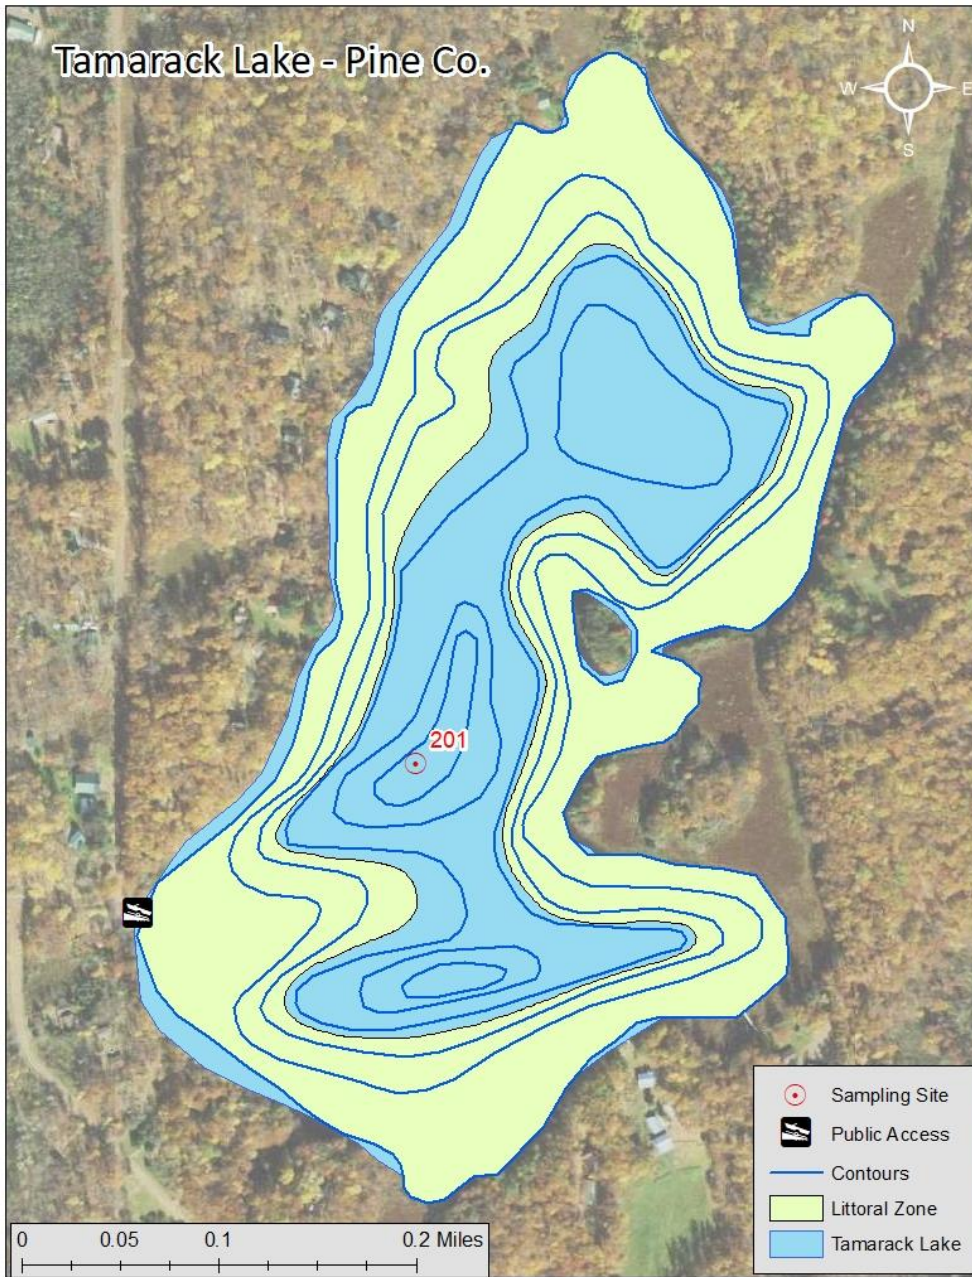
Figure 1. Map of Tamarack Lake with aerial imagery and illustrations of lake depth contour lines, sample site locations, and public access points. The light green areas in the lake illustrate the littoral zone, where the sunlight can reach the bottom of the lake.

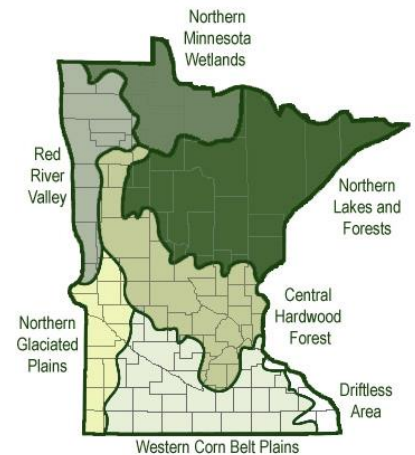
Figure 2. Minnesota ecoregions

Minnesota is divided into 7 ecoregions based on land use, vegetation, precipitation and geology. The Minnesota Pollution Control Agency (MPCA) has developed a way to determine the "average range" of water quality expected for lakes in each ecoregion¹ (Table 4). Tamarack Lake is in the Northern Lakes and Forests Ecoregion (Figure 2).

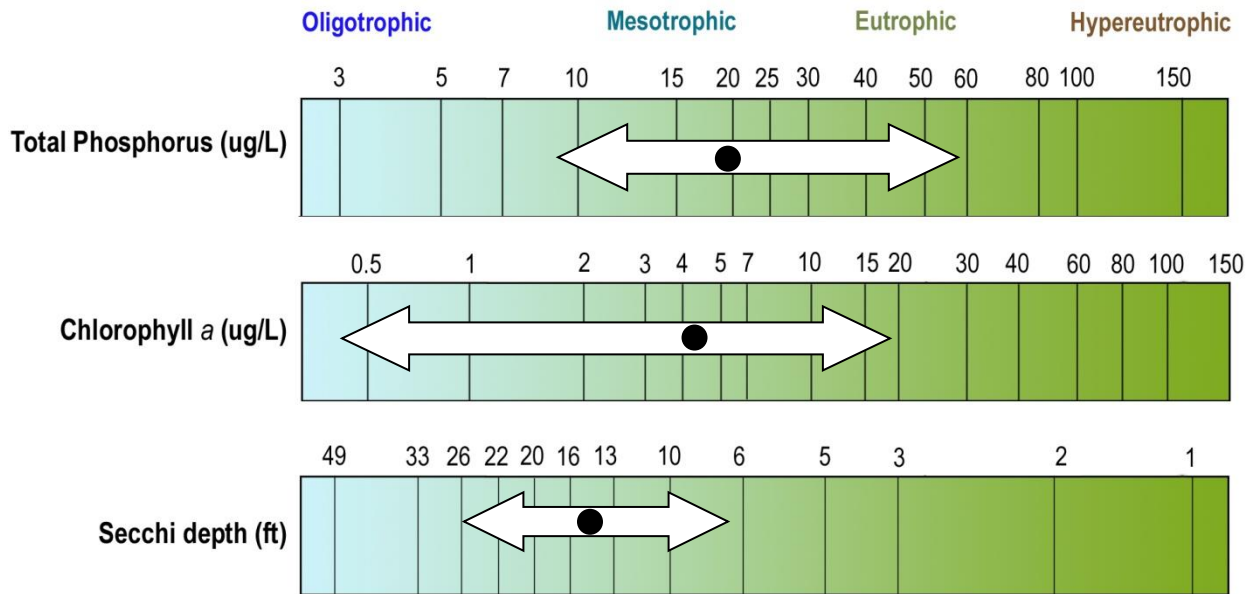
Figure 3. Tamarack Lake total phosphorus, chlorophyll a, and transparency historical ranges. The arrow represents the range and the black dot represents the historical mean (Site 201). Figure adapted after Moore and Thornton, [Ed.]. 1988.

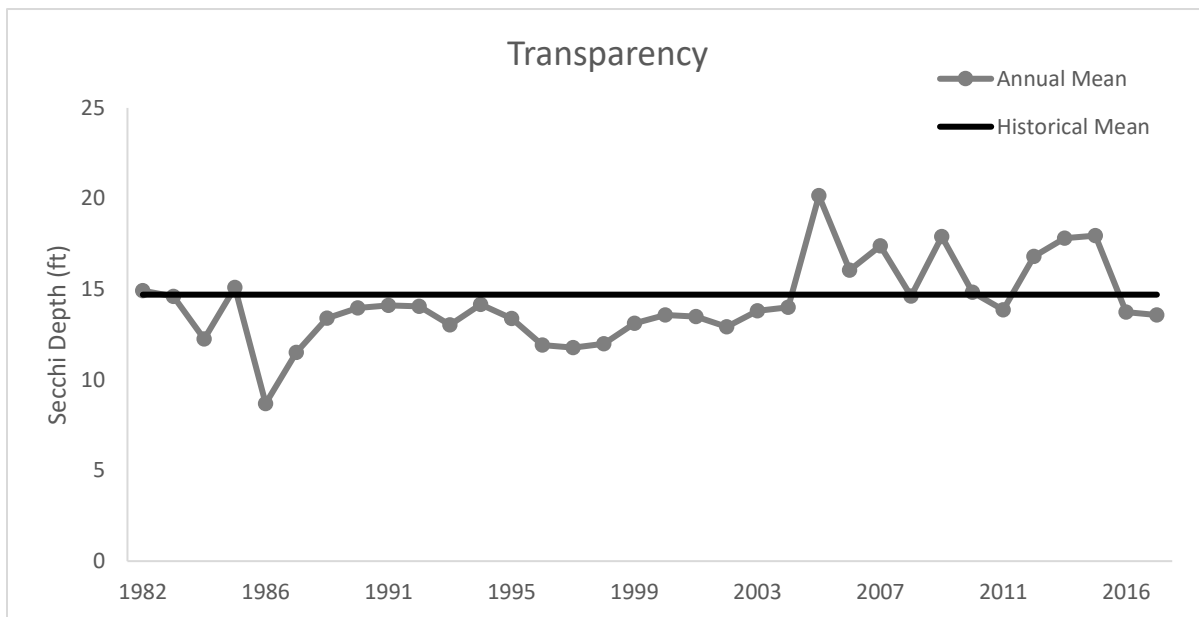
The annual mean transparency in Tamarack Lake ranges from 8.7 to 20.2 feet (Figure 4). The annual means hover fairly close to the long-term mean of 14.7. For trend analysis, see page 9. Transparency monitoring should be continued annually at site 201 in order to track water quality changes.

Figure 4. Annual mean transparency compared to long-term mean transparency

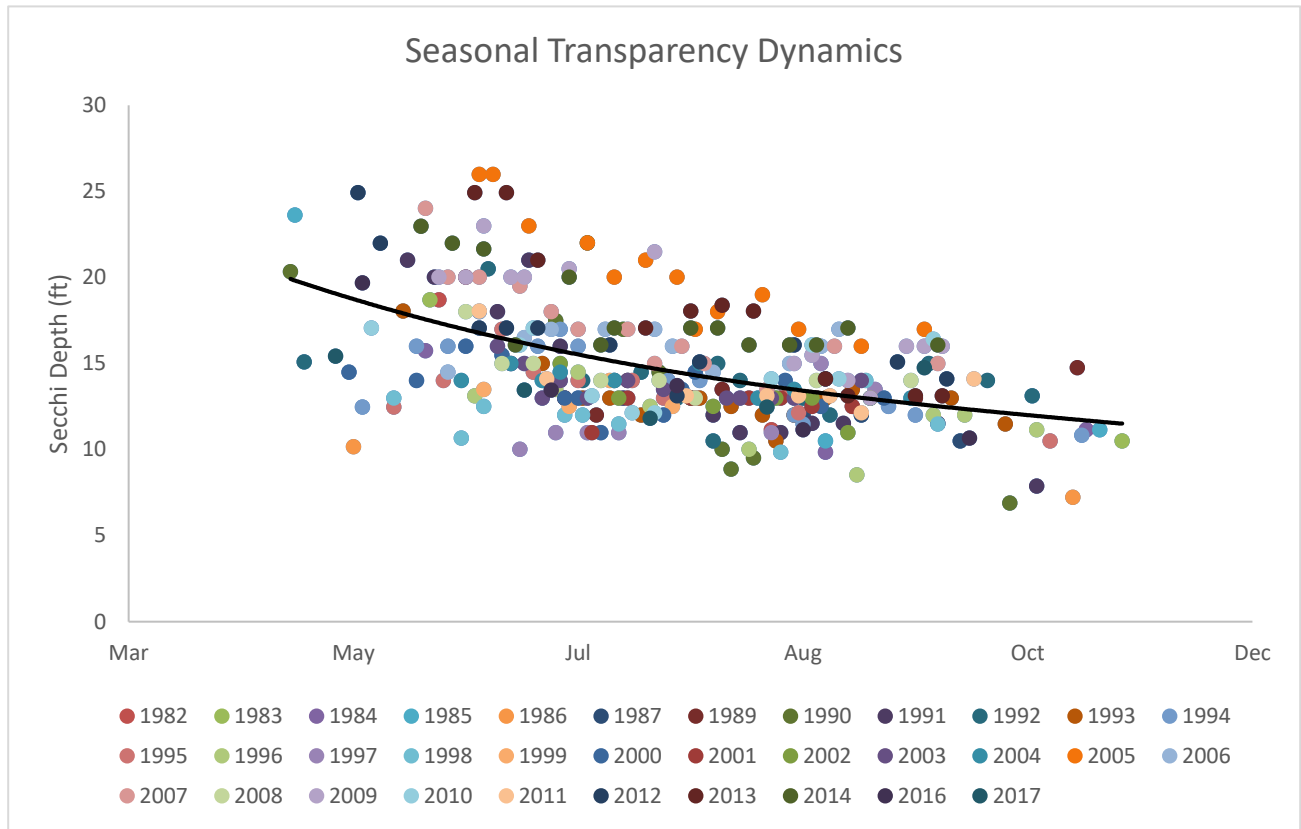
The maximum Secchi reading is usually obtained in early summer. Tamarack Lake transparency is high in May and June, and then declines through August. The transparency then rebounds in October after fall turnover. This transparency dynamic is typical of a Minnesota lake. The dynamics have to do with algae and zooplankton population dynamics and lake turnover.

Figure 5. Seasonal transparency dynamics and year to year comparison (Site 201). The black line represents the pattern in the data.

It is important for lake residents to understand the seasonal transparency dynamics in their lake so that they are not worried about why their transparency is lower in August than it is in June. It is typical for a lake to vary in transparency throughout the summer (Figure 5).

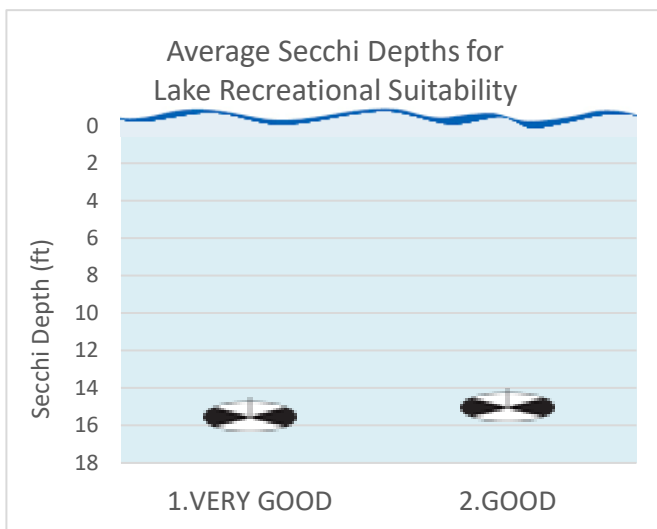
Figure 6. Average Secchi depth (ft) for each lake recreational suitability rating

When volunteers collect Secchi depth readings, they record their perceptions of the water based on the physical appearance and the recreational suitability. These perceptions can be compared to water quality parameters to see how the lake "user" would experience the lake at that time. Looking at transparency data, as the secchi depth decreases, the perception of the lake's physical appearance and recreational suitability decreases (Figures 6-7).

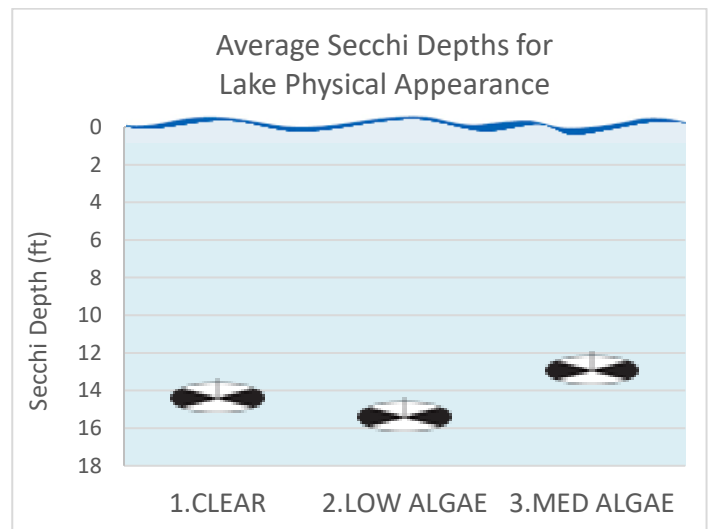
Figure 7. Average Secchi depth for each lake physical appearance rating

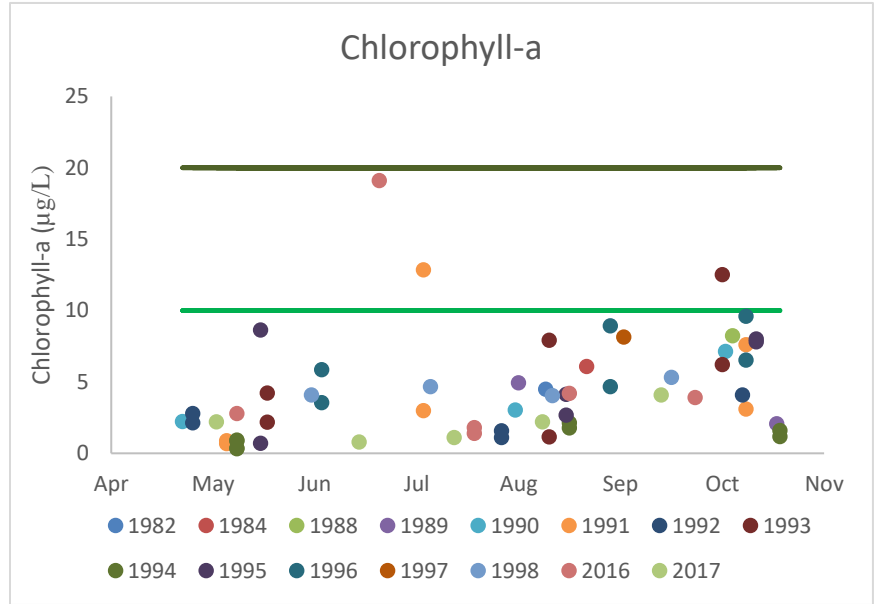
Chlorophyll *a* was evaluated in Tamarack Lake at site 201 from 1982-1998, and in 2016-2017 (Figure 8). Chlorophyll *a* concentrations mostly remained below 10 $\mu\text{g/L}$ in all the sample years, with only three samples indicating algae blooms. There was not much variation over the years monitored and chlorophyll-*a* concentrations remained relatively steady over the summer.

Figure 8. Chlorophyll *a* concentrations ($\mu\text{g/L}$) for Tamarack Lake at site 201

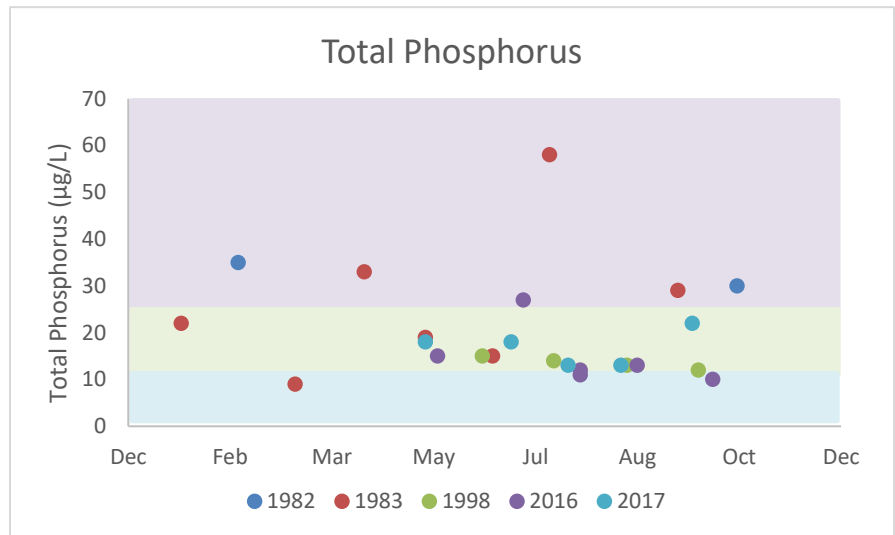
Total phosphorus was evaluated in Tamarack Lake in 1982-1983, 1998, and 2016-2017 at site 201. The data do not indicate much seasonal variability. Majority of the data points fall into the mesotrophic/eutrophic classification (Figure 9).

Figure 9. Historical total phosphorus concentrations ($\mu\text{g/L}$) for Tamarack Lake at site 201

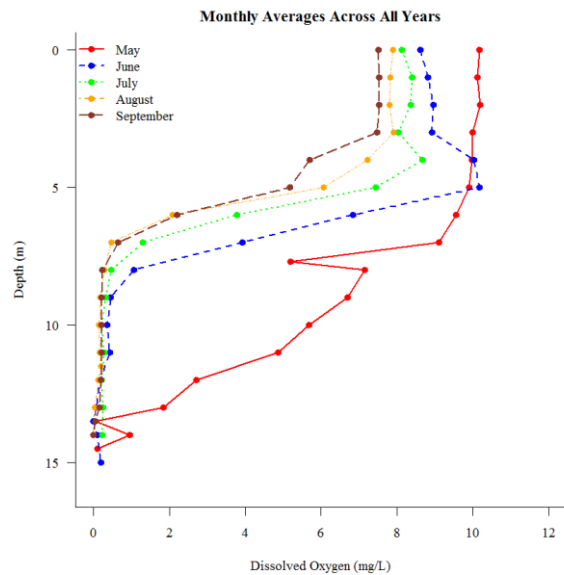
Figure 10. Representative dissolved oxygen profiles from site 201 year in Tamarack Lake

Tamarack Lake is a moderately deep lake, with a maximum depth of 47 feet. Dissolved oxygen data was collected in 1982-1986, 1989-1998, and 2016-2017 at site 201. The dissolved oxygen profiles from this data show a stratified lake throughout the summer where the DO crashes around 7 meters (23 ft) down. Tamarack Lake is deep enough that spring and fall turnover only mix the upper portion of the water, leaving the lake bottom without a saturated oxygen supply (Figure 10).

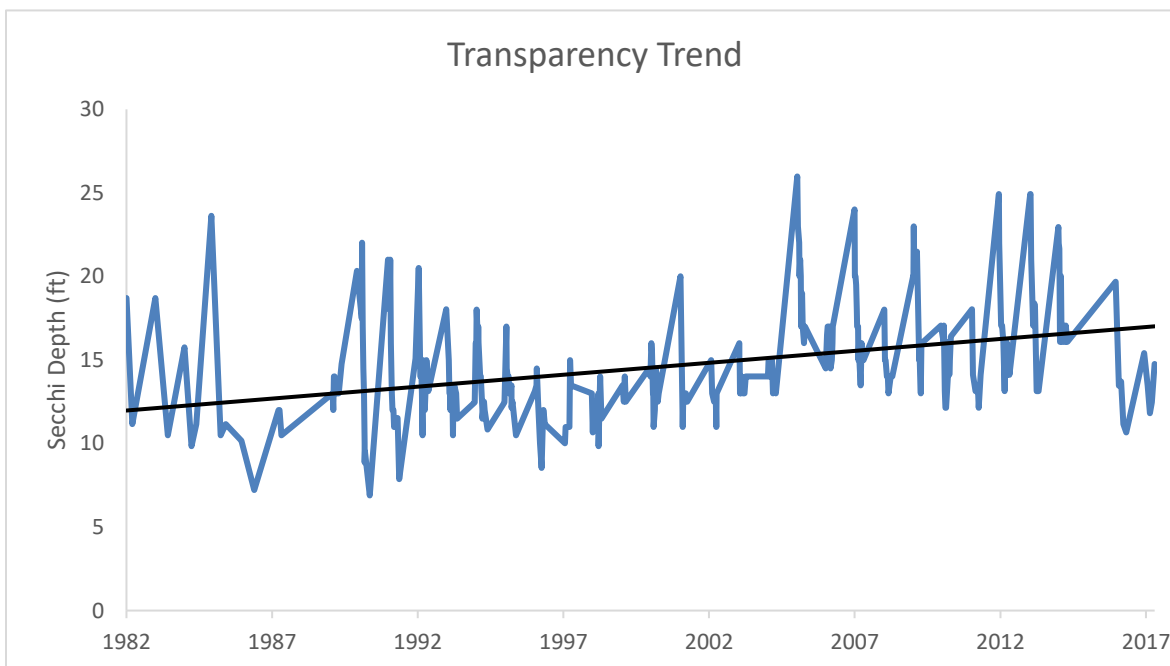
Tamarack Lake had enough data to perform a trend analysis on transparency, but insufficient data for trend analysis on water chemistry (Table 8). The data was analyzed using the Mann Kendall Trend Analysis, which shows very strong evidence (99.9%) for an increasing transparency trend (Figure 11). It appears that since around 2002 the transparency has been higher than in the 1980s and 1990s. Transparency monitoring should continue at site 201 so that this trend can be tracked in future years.

Figure 11: Transparency (ft) trend for site 201 from 1982 - 2017

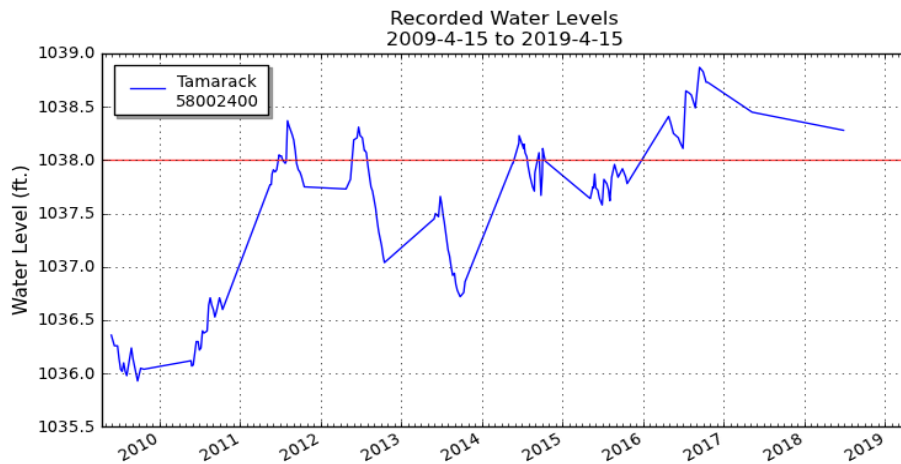
Tamarack Lake is land locked, meaning no significant inlets or outlets connect to the lake. Water levels in this system are mainly affected by precipitation (i.e. rain, snowmelt), which can cause strong fluctuations in the water level with major storm events. The total watershed area for Tamarack Lake is fairly large, but it is within a headwaters lakeshed, meaning that no other lakesheds flow into it.

Figure 14: Monitored water levels in Tamarack Lake, Source: MN DNR Lakefinder
